# PGM-FI Control System

## Troubleshooting Flowchart — Throttle Angle Sensor

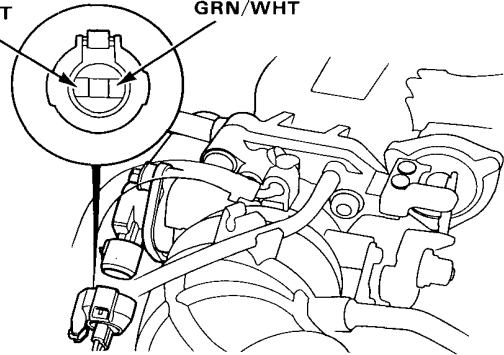
Disconnect the 3P connector from the throttle angle sensor.

Measure voltage between YEL/WHT (+) terminal and GRN/WHT (-) terminal.

YEL/WHT

GRN/WHT

**Repair open in GRN/WHT wire between ECU (C12) and throttle angle sensor.**

Repair open in YEL/WHT wire between ECU(C13) and throttle angle sensor.
